A SUMMER CONFLUENCE: LAUNCHING TWO RESTORED MORRIS CANOES

Revisiting Joe Seliga's Legacy, and Celebrating YMCA Camp Widjiwagan's Ninetieth Anniversary – Part 2

By Matt Poppleton, Alex Comb, Tim Eaton & Bruce Casselton

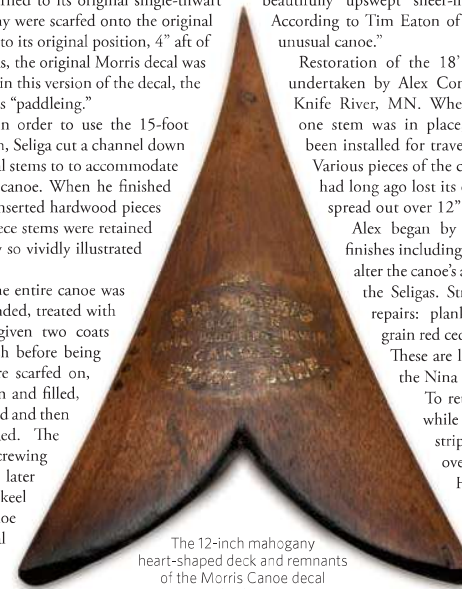
The 12-inch mahogany heart-shaped deck and remnants of the Morris Canoe decal (version two). Photo: Tim Eaton

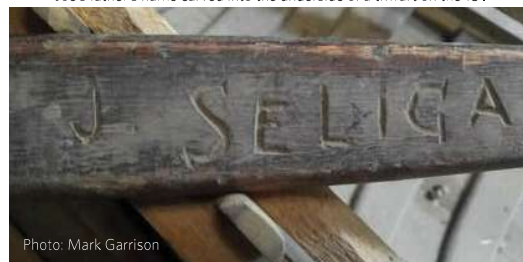
Joe's father's name carved into the underside of a thwart on the 18'.

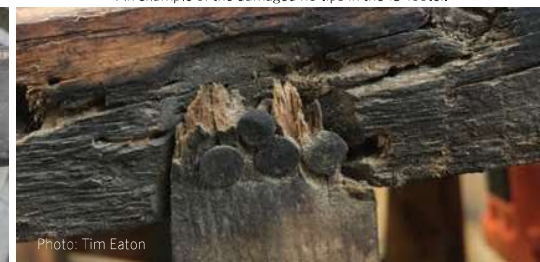
An example of the damaged rib tips in the 15-footer.

Restoration of the 15-foot Morris required the installation of new Sitka spruce gunwales, repair of many rib tops, and back-side repair of breaks and cracks in 41 ribs including two that Joe Seliga had cut away near the stems as part of the canoe's use as a building form. Finally, some of the planking was replaced including sections from the bow that were charred in the Seliga shop fire.

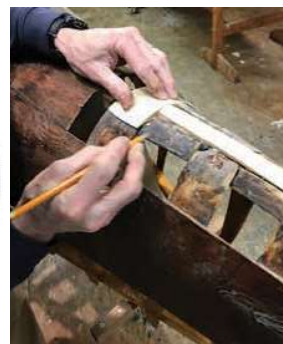
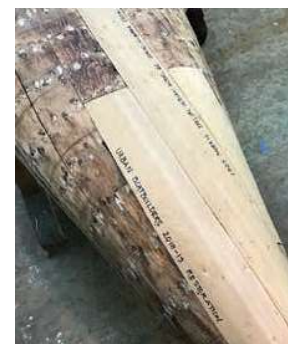
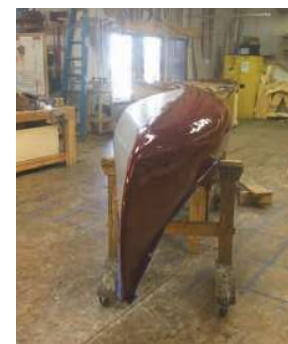
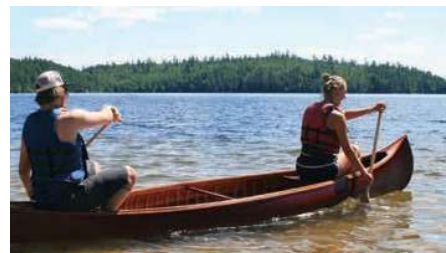
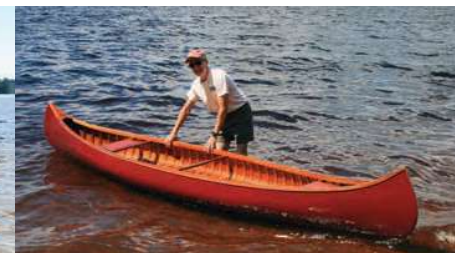
Facing page: The three-piece splayed stem that Joe adapted to provide a stem channel for building the 16-foot Seliga canoes. Photo: Tim Eaton
This page starting top left, clockwise: Fitting rib piece for placement; The stem areas are repaired and the restoration crew has signed-off on the wood repairs; Bending rib for repair of missing rib piece near the splayed stem band. Photos by Bruce Casselton.
Center: The 15' ready for the water; Bottom: The 15' ready for paddlers; The 15' Morris canoe launched at last! Photos by Tim Eaton

Jerry Stelmok noted that in order to use the 15-foot Morris as a canoe-building form, Seliga cut a channel down the center of each of the original stems to accommodate the stem for each newly-built canoe. When he finished using the canoe as a form, he inserted hardwood pieces in that channel. These three-piece stems were retained during restoration because they so vividly illustrated the canoe's unique history.
